Reliability Study of Grid Connected PV Systems

Field Experience and
Recommended Design Practice

Report IEA-PVPS T7-08: 2002

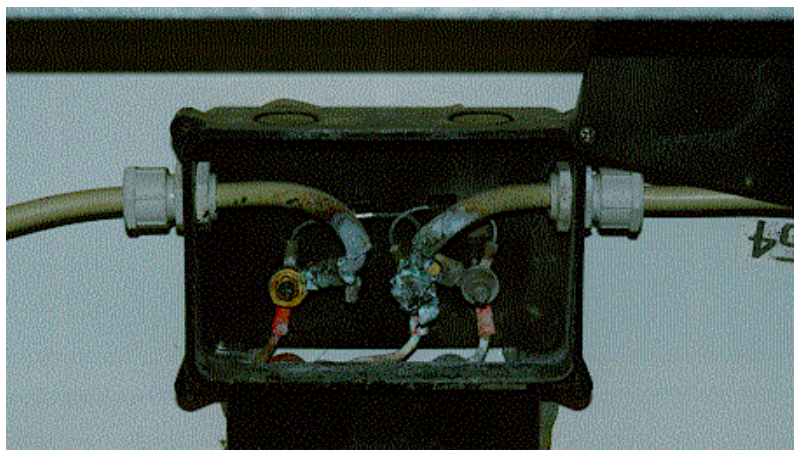
Loose or broken connections can be caused by poor workmanship during installation. However, these defects can also be caused by thermal cycling, which works the screwed connections loose with time. Sometimes terminals were found corroded after only 2 years (figure 10). Presumably, condensing moisture could not drain and accumulated in the junction box (j-box).

In a few cases broken printed circuit boards (PCB) in junction boxes were reported, which caused arcing across the fissures. Possibly, the cracks were caused by too much torque or pressure. Depending mainly on the operating voltage, these faults can lead to an electric arc and subsequently to destruction of the module junction box.

Fig. 10: Corroded contacts probably due to lack of water drainage. This connection will not last 20 years (Laukamp, Häberlin et. al.)

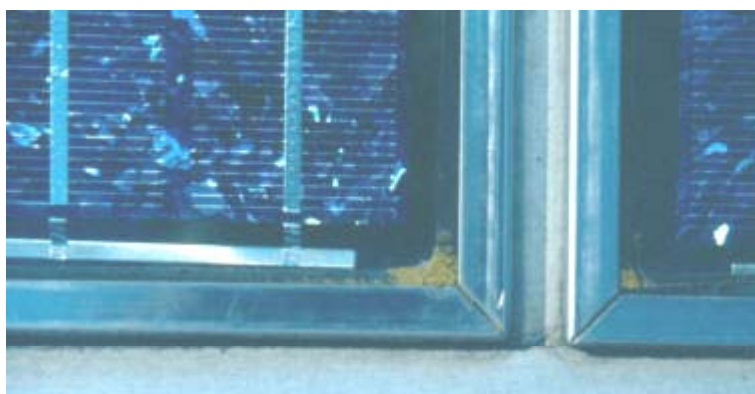
The impact of soiling is strongly site dependent. PV Modules on the roof of the former Fraunhofer ISE building showed virtually no soiling after 10 years of operation, only very little growth of lichen (Figure 11).

Fig. 11: Modules at Fraunhofer ISE after 11 years of operation.

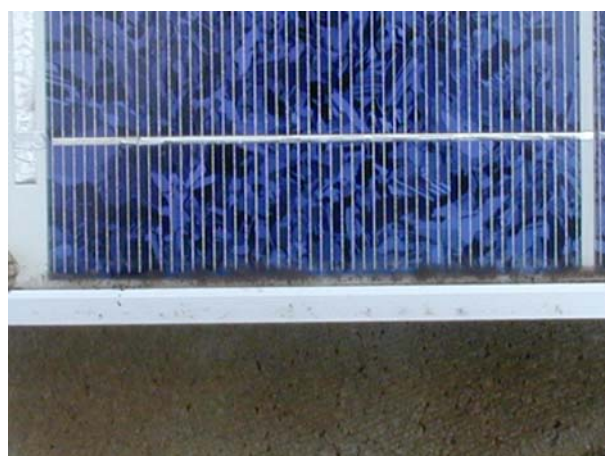
The most critical part of a module is the lower edge. Especially with rather low inclinations, soiling at the edge of the frame occurs. By often repeated water collection in the shallow puddle between frame and glass and consecutive evaporation dirt accumulates (Fig 13). Once it causes shading of the cells, this dirt reduces the available power from a module. Densely packed modules with little distance between cells and frame are especially concerned. Laminates allow free run-off of the water. Therefore, they are less prone to this effect (Fig. 14).

Fig. 14: Dirt accumulation above the frame (ewz).
