Reliability Study of Grid Connected PV Systems

Field Experience and
Recommended Design Practice

Report IEA-PVPS T7-08: 2002

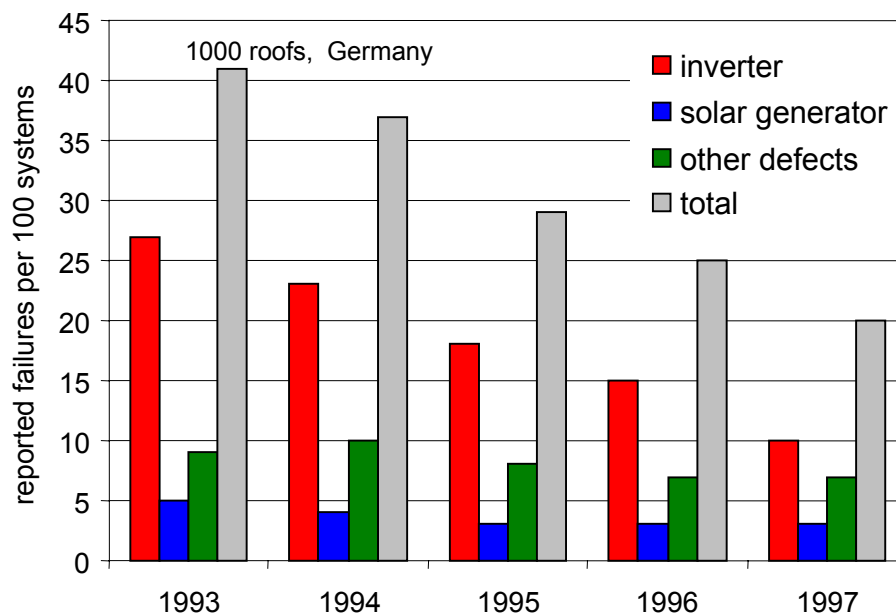
Figures 1 to 3 show results of the queries. Type of failure and failure frequency per 100 systems are presented. Results in figures 1 and 2 are biased insofar as systems with "no response to questionnaire " were counted as "no trouble".

Fig: 1: Failures by main component as reported by the system owners under the »1000-Roofs-Programme« (Erge et al. 1998).

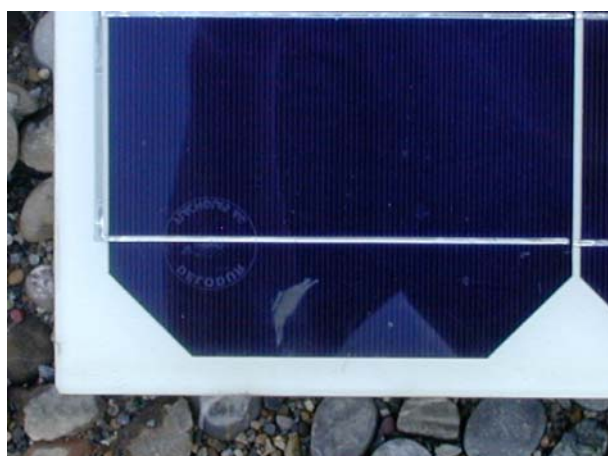
Fig. 15 This laminate is free of dirt (ewz).
