Arcing in PV arrays

Martin Cotterell – Sundog energy Ltd

Arcing in PV DC-Arrays

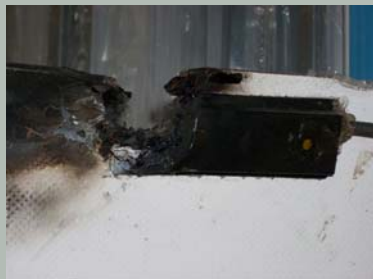
Module hotspots

Failure in junction box

- High resistance fault in junction box
 - Results in overheating
 - Results in further increase in resistance
 - Results in arc
-
- Arc only halts when irradiation level falls significantly, or contact burnt out

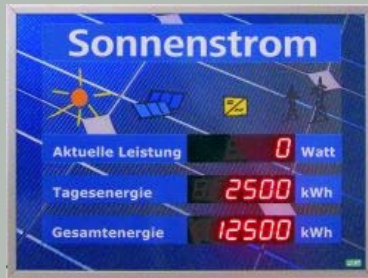
System stops working

Should be obvious to system owners!

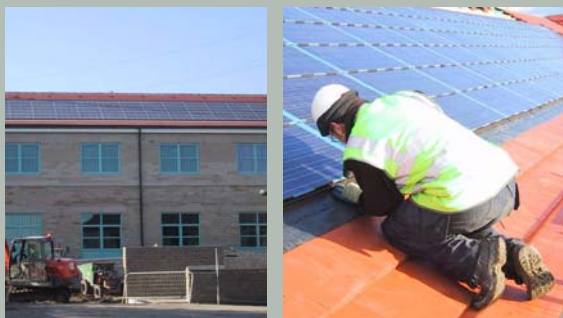
Glass failiure

For integrated systems:

- Leaking roofs / facades ?

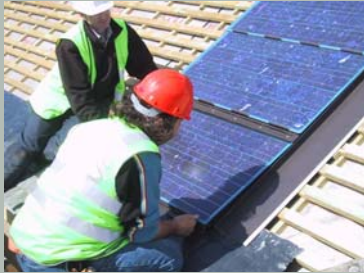
Fire spread beyond PV array?

What is the material directly behind the array?

- Wood?
- Bitumen?
- Plastic / Rubber?

Spread of flame:

- Direct
- Flaming droplets?

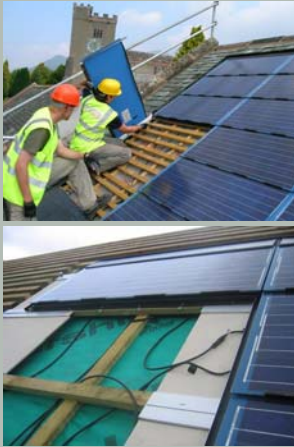
Remedial works

Remove, inspect & test

Install fire barrier where flammable materials beneath array?

Fire barrier beneath whole module, or just beneath junction box zone?

Barrier must be fit for purpose – prevent spread of flame for the maximum possible duration & intensity of arc
